Operational Playground Inspection

Client: Banwell Parish Council
Inspector: Colin Lewis
RPII Inspector No: OPO536
Date: 28/2/19 **Time:** 12.10
Site Address: Recreation Ground
Westfield Rd, Banwell BS29 6BS

Client: Banwell Parish Council
Inspector: Colin Lewis
RPII Inspector No: OPO536
Date: 13/2/19 **Time:** 12.15
Site Address: Multi Use Games Court.
Westfield Road Recreation Ground BS29 6BS

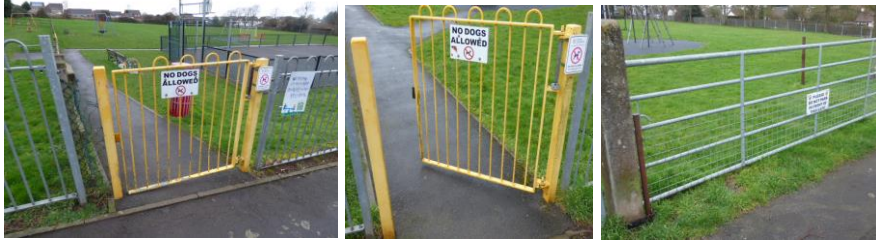
Asset: Entrance Gates from Road and Roadside fencing

Findings: Galvanised bow top fencing is satisfactory. Entrance gate near to Nursery footpath is not fully self-closing. This gate is also catching on the ground slightly.

Risk Assessment: Low

Recommended Action: Lubricate hinges and springs regularly .Fit nylon washers to hinges. Gates should close within a target speed of 4-8 seconds .

Inspectors note: Signs fitted to gates can often affect the closing speeds during windy weather as they can act like a sail. Consider relocating signs to adjacent fence

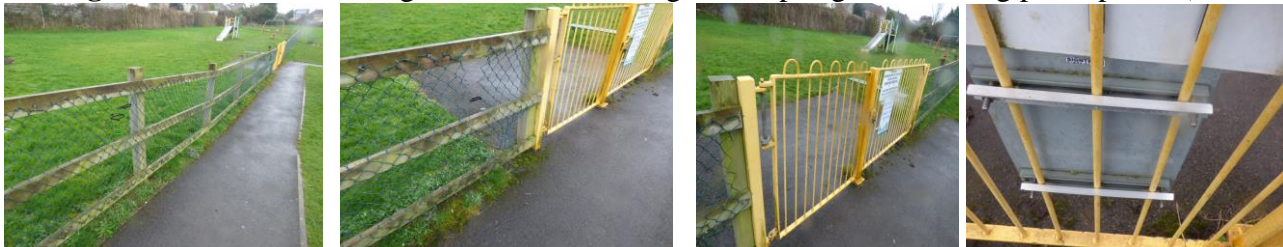
Asset: Timber fence and combination gate to toddler area. **Manufacturer:** Steelway gate

Findings: There is minor damage to mesh on fencing. Gate spring bar securing pin is proud (incorrect pin)

Risk Assessment: Low

Recommended Action: Remove excess threads to sign bolts (min 8mm of exposed thread) Fit correct pin to gate .And repair mesh to fence. Relocate signs to adjacent fence

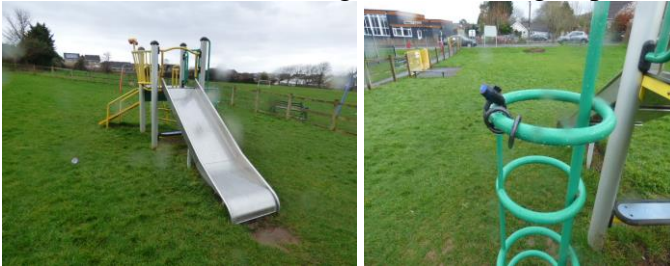
Asset: Slide Climber

Findings: Padlock and chain attached to climbing pole. Square deck panel to unit is slightly warped. Grassmats have sunk into ground reducing impact absorbency

Risk Assessment: Low.

Recommended Action: Remove padlock and chain. Monitor surfacing in hot dry conditions due to mats sinking there will be limited impact absorbency

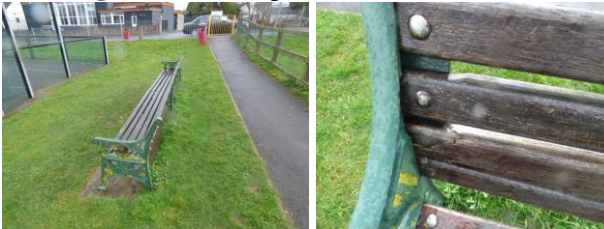
Asset: Double bench seat

Findings: Slat damaged to bench.

Risk Assessment: Low

Recommended Action: Repair or replace slat.

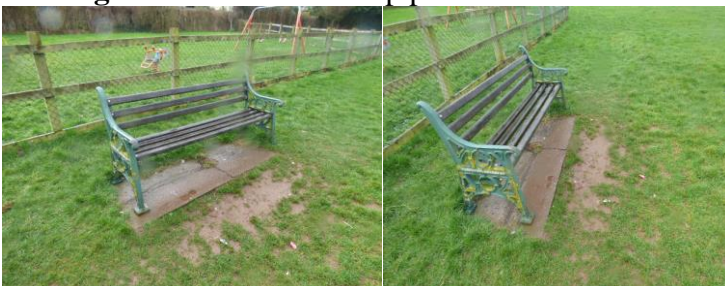
Asset: Bench seat

Findings: Soil erosion and trip point to front of bench

Risk Assessment: Low

Recommended Action: Reinstate soil to front of bench.

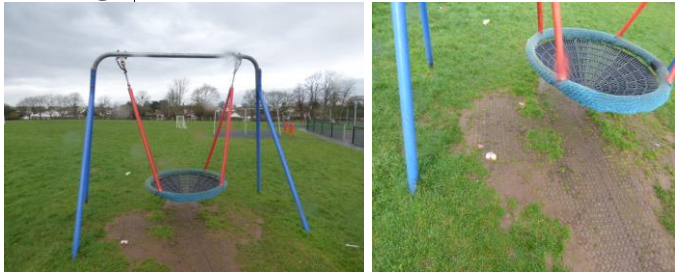
Asset: Basket Swing

Findings: Grassmats have sunk into surface reducing impact absorbency

Risk Assessment: Low

Recommended Action: Monitor

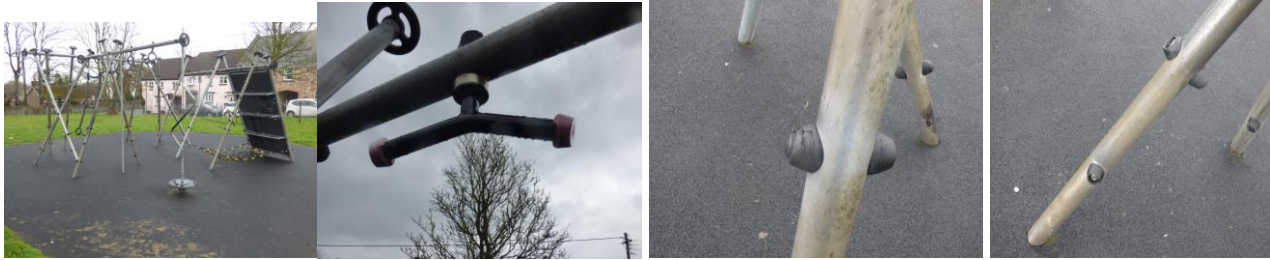
Asset: Rec Trust papers
Junior Climber

Findings: 8 no Damaged /missing rubber bolt cover /grips .Minor movement to monkey bar grip bearing. Wet pour is satisfactory but there are old grass cuttings on surface which are decaying and will make surface slippery

Risk Assessment: Low

Recommended Action: Replace missing or damaged caps .Tighten bearing fixing bolt to trapeze handle. Keep surface clear of grass cuttings.

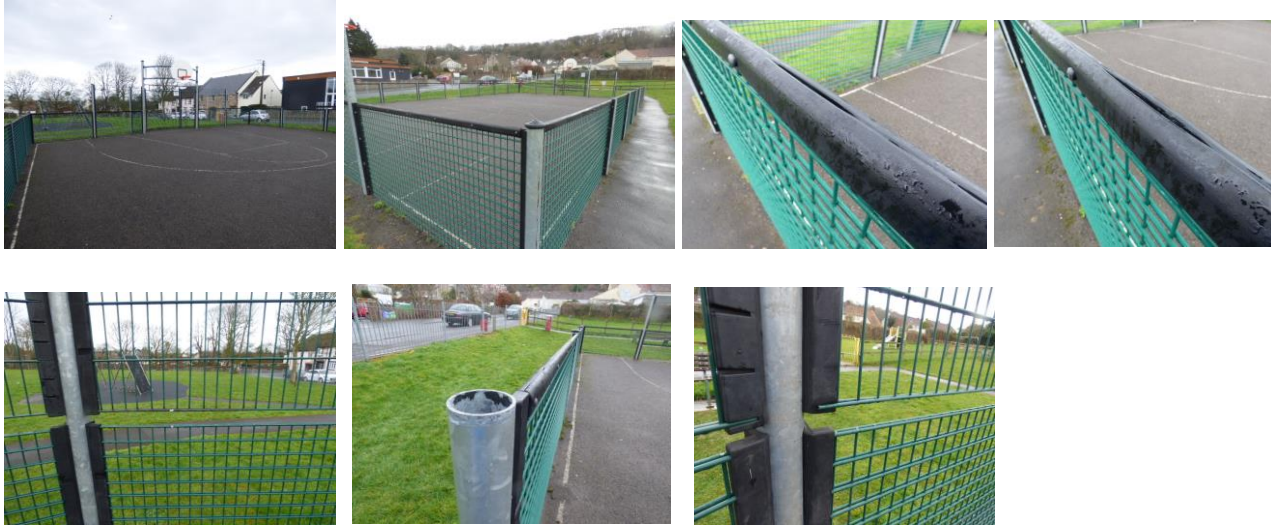
Asset: Multi Use Games Court

Findings: At time of inspection there were 6 no post caps missing.
The rubber capping to top of rebound panels is opening up between the 2 sections.
The rebound mesh is coming away from its rubber edge behind the goal

Risk Assessment: Low

Recommended Action: Replace all missing caps. Monitor wear to rebound panel capping's. Repair rebound panel behind goal
