# BANWELL

## CONSERVATION AREA APPRAISAL AND MANAGEMENT PLAN

27/09/2021

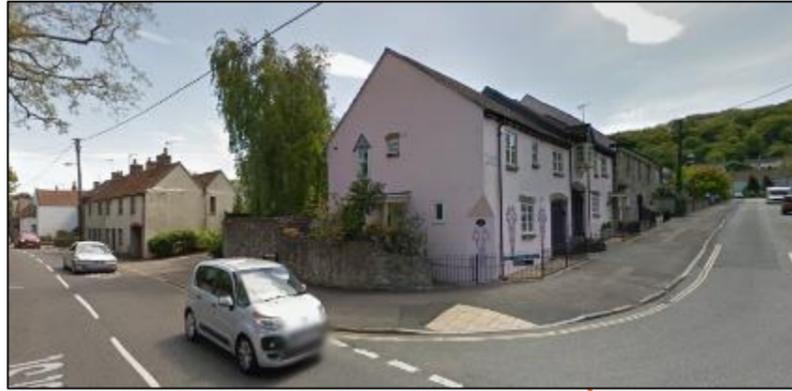
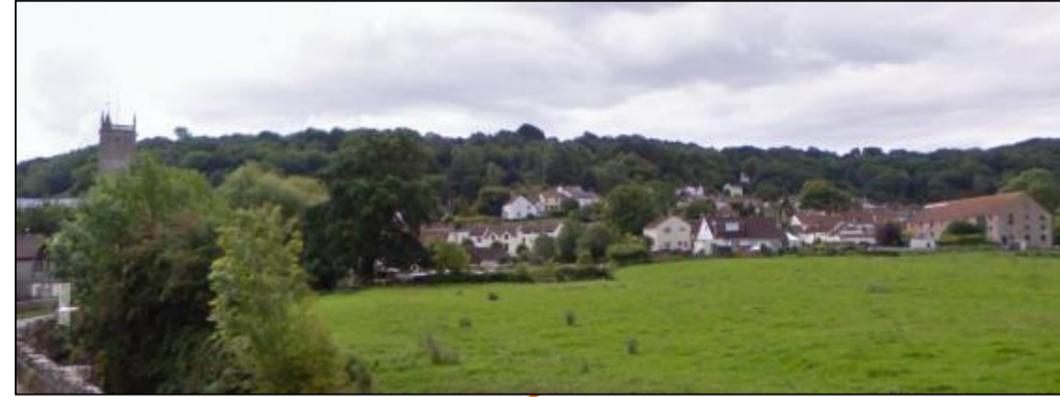
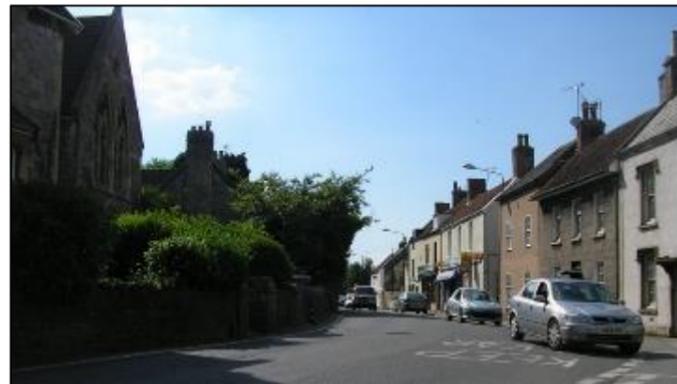
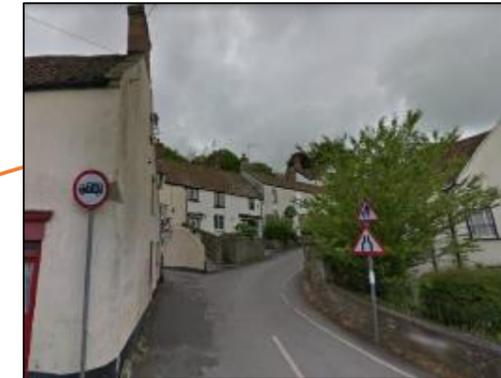
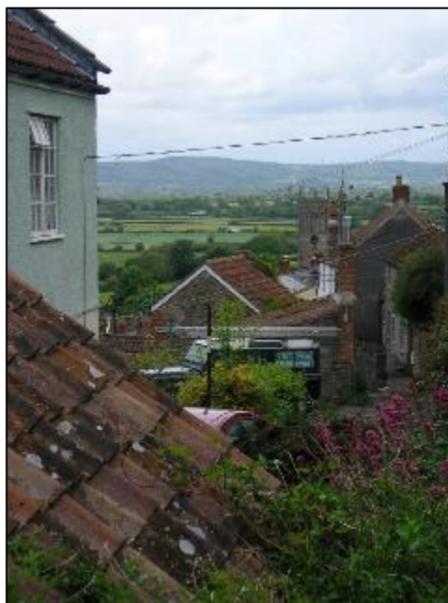
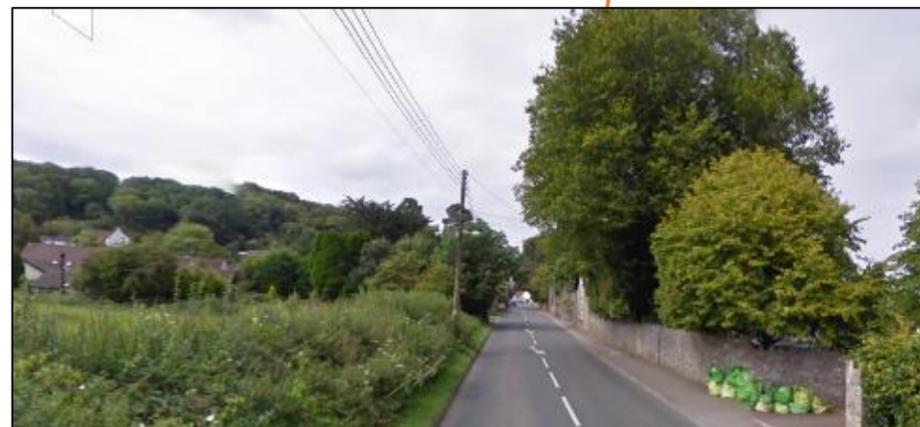
Figure 3: Key views within and into/out of the Conservation Area

Key views around the village have been identified on the map below, and often include the local landmark of St Andrew's Church:

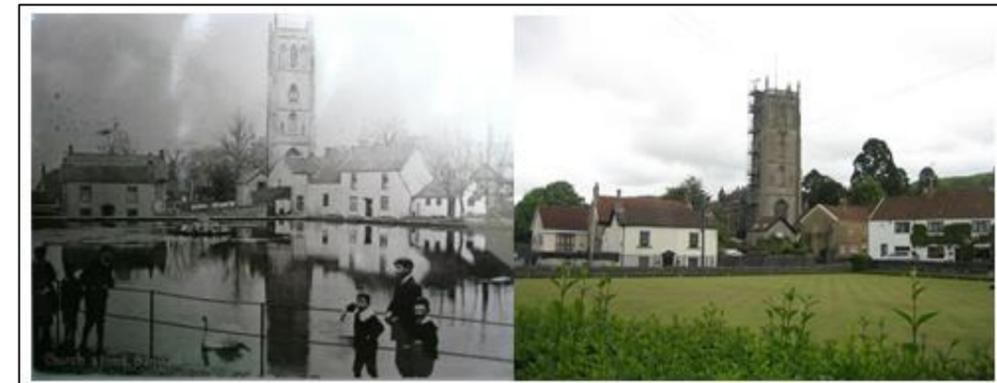
Figure 4: Former mill pond and Bowling Green

Open space within the village is minimal, comprising of the churchyard, some small private front gardens and the Bowling Green. The Bowling Green was once the location of a pond formed from a spring welling up through the ground. The spring was capped in 1926 and the location provides impressive street level views of St Andrew's Church.

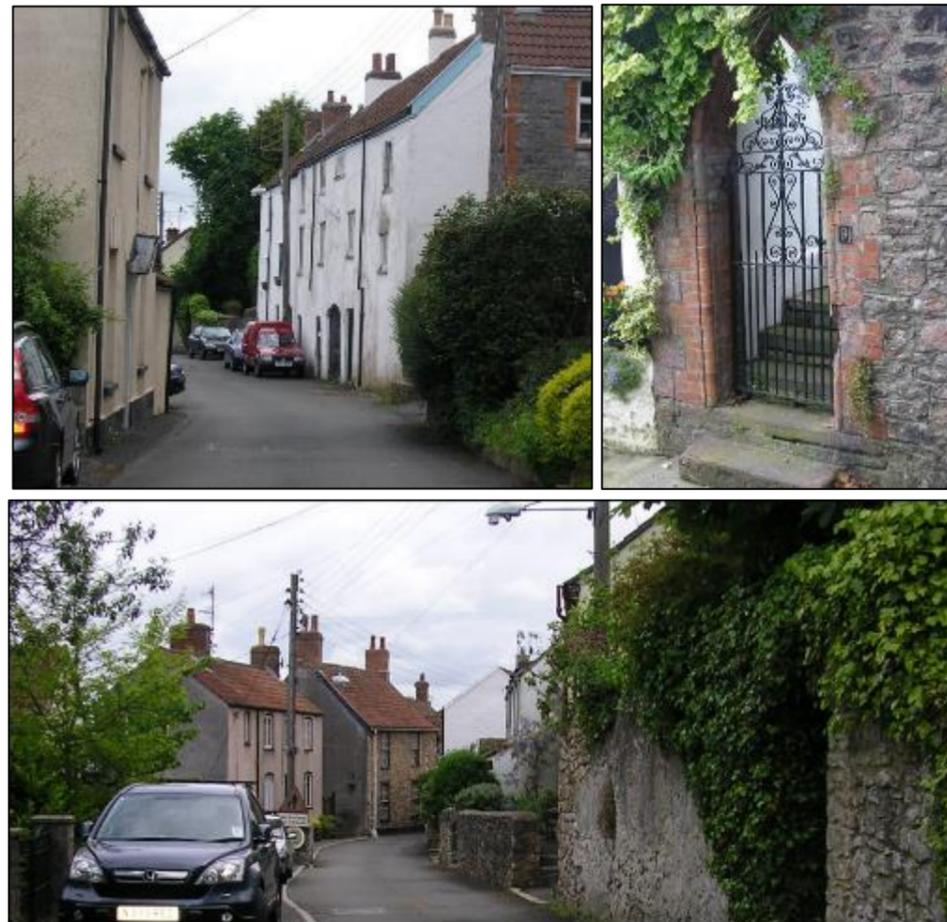
Figure 7: Special details of stone walls and small enclosed gardens

Pinch points are characteristic of the area and create intimate areas of enclosure. These enclosed areas have been shaped by continuous building frontages on the edges of roads and historic stone walls which are particularly evident along High Street.

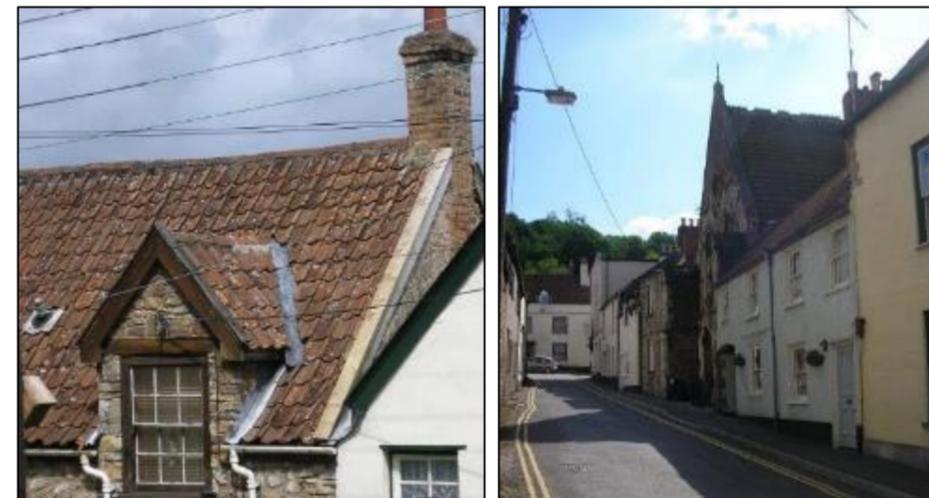
Figure 8: Examples of roofing materials

Originally many of the older buildings would have been thatched; this can be surmised from the pitch and roof details evidenced in many of the cottages. However, no thatched properties remain in the village and the majority of roofs now have red clay tiles with some occasional slate roofs. It is likely that the tiles may have been made from local clay found on Banwell Moor and the evidence of an old brick works supports this theory. Most of the buildings have been rendered and painted, hiding their original materials. The predominant colours of the village are white and pastel coloured buildings, red tiled roofs and grey rough rubble stone walls.

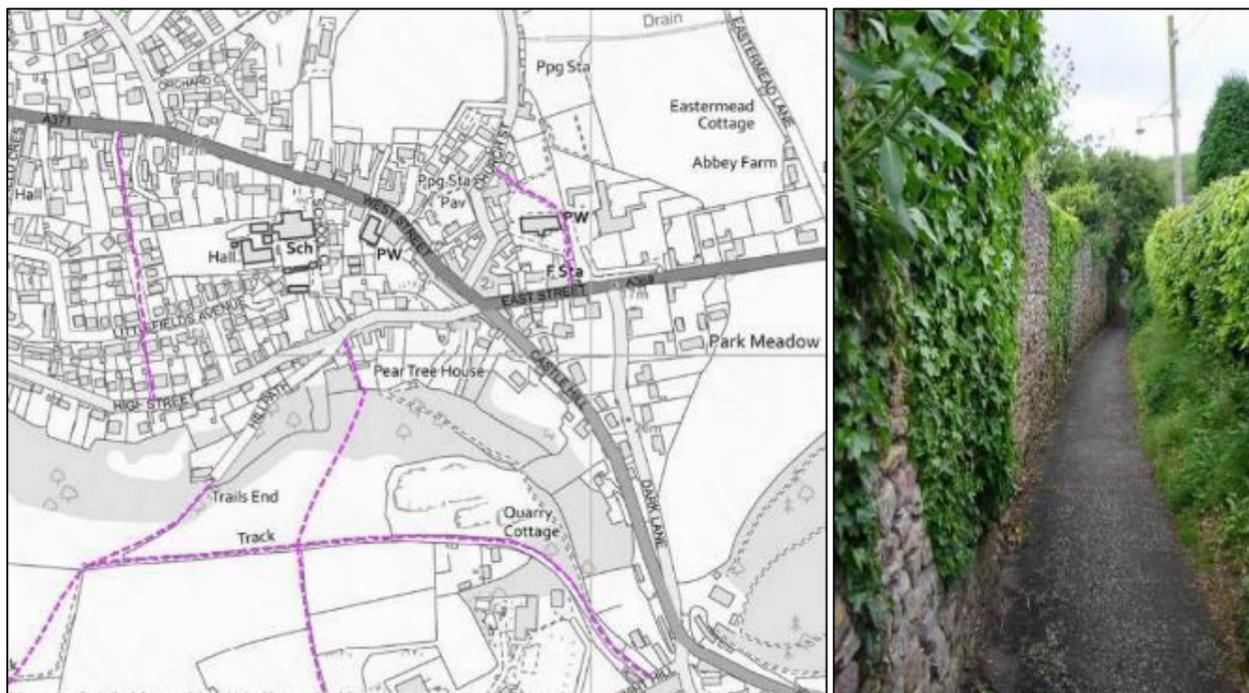
Figures 9 & 10: Public Rights of Way in and around the village / historic alleyway

Historic alleyways are still evident within the medieval core of the village and its westerly expansion and provide a shortcut on foot while offering visitors intriguing glimpses into other areas of Banwell.

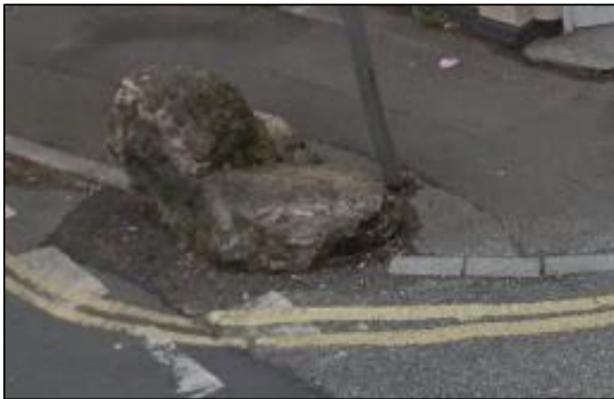
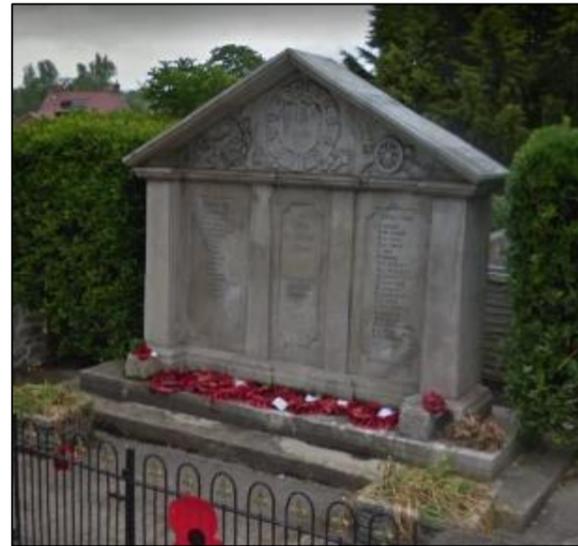
Figures 13 & 14: The Butstone and War Memorial

The Butstone is a feature at the corner of Church Street and West Street. Records indicate it has been there at least since the early 18<sup>th</sup> century. It is believed it was both a mounting stone for riders and then, as now, to prevent traffic striking buildings (hence its name).

The War Memorial on West Street is another key historic feature of Banwell and was unveiled on 1<sup>st</sup> May 1921.

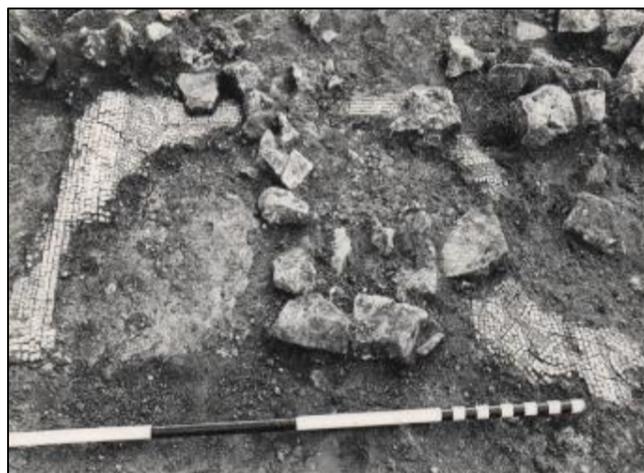
Figure 15: Mosaic discovered at the Romano-British villa site

A substantial Romano-British building was identified to the north of Banwell village in 1967, after the discovery of part of a bath house of a probable villa during the cutting of a pipe trench. Excavations revealed remains of mosaics dating to the 3<sup>rd</sup> and 4<sup>th</sup> centuries AD (fig. 15). The site is a Scheduled Monument and is visible today as a group of well-defined and well-preserved building platforms.

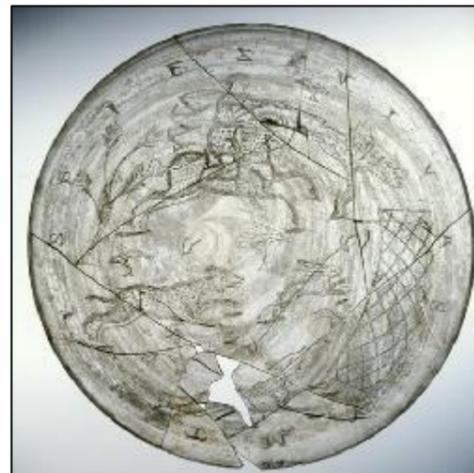
Figure 16: Wint Hill Bowl © British Museum

A significant discovery was made during the excavations at Winthill in the 1950s, in the form of an engraved glass bowl depicting a hunting scene (fig.16). The bowl was imported from Cologne and dates to between 325 and 350 AD.

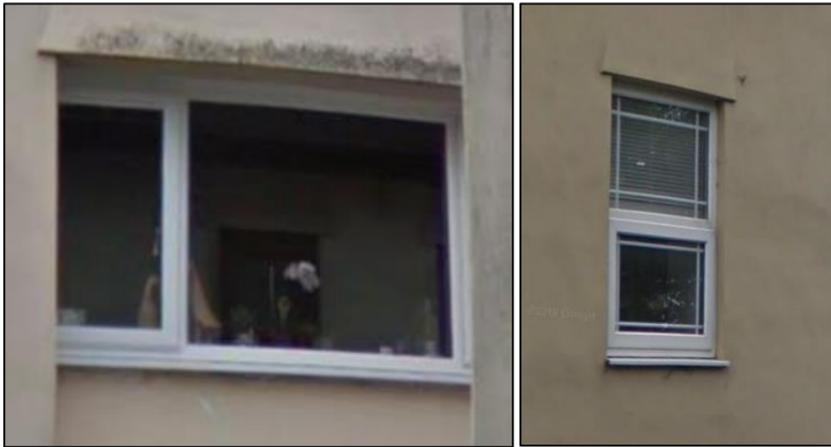
There are various types of uPVC replacement of traditional windows and doors as well as examples of poor replacement windows and doors that although older do not match the local vernacular, for example, mock leaded windows or metal framed windows.

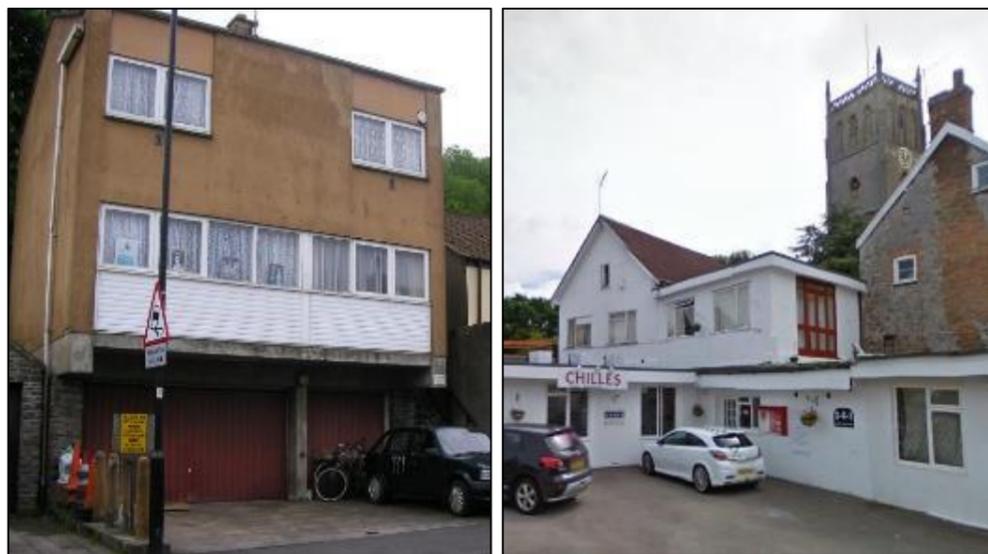
Some modern additions such as side extensions or conservatories have been made to older buildings and some newer flats and bungalows have replaced buildings bombed during the Second World War.

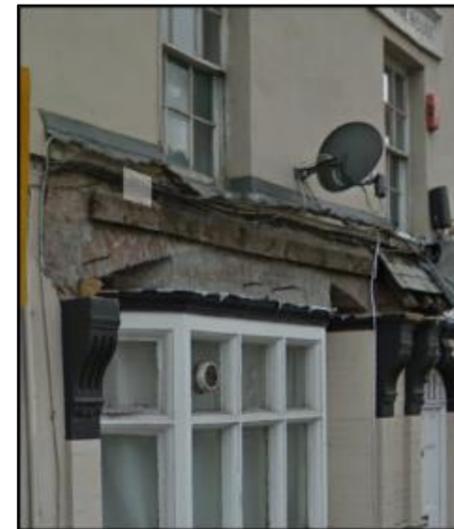
There are several empty shops, some of which are boarded up which make the core of the village appear run down. This is not helped but the damage caused to some of the buildings by lorries and other vehicles hitting these in the narrower parts of the village. As a result of this building owner have lost moral at the continued issues and cost of repairs form the resulting damage.

Along parts of the A371 and A368 some buildings are dirty from mud and dirt being thrown up from the road and general exhaust emissions. The high levels of traffic and proximity to the road make it difficult for homeowners to carry out maintenance to their properties.

<b>Traffic Issues</b>	Traffic along the A371 causes damage to nearby properties and prevents owner from carrying out maintenance.  The busy and narrow nature of the road here makes it unsafe for pedestrians and has been a cause in the closer of the number of shops in the location	Work with all parties on the delivery of the Banwell bypass especially where the spur road will enter the conservation area.  Encourage sensitive reopening and maintenance of the buildings along West Street once the bypass is in place.
<b>Improve historic interpretation of the village</b>	There is currently a lack of historic interpretation around the conservation area.	Work with the Parish Council where needed on the plans to place a historical information board at the entrance to the car park and some blue plaques on important sites around the village.

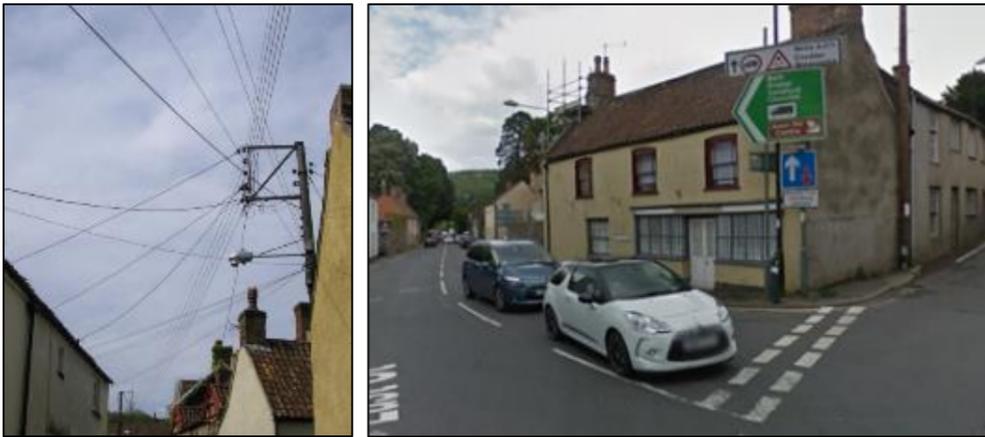
One of the main negative features of this road are two sets of large road signs, one situated on East Street on the approach into the village and the other outside a listed building where East Street meets Castle Hill and West Street.

Another feature is the large number of overhead wires that dominate when viewing the church from the path around the bowling green.

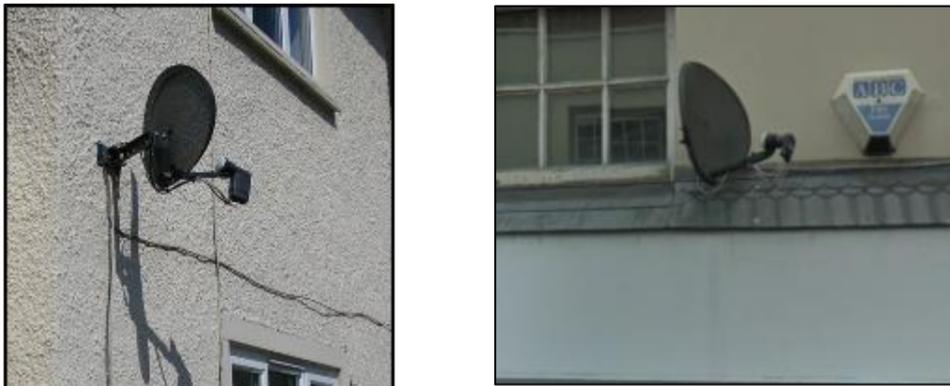
Satellite dishes can be seen on the front of some properties which detract from the historic character of the village. Issues with windows being replaced without authorisation still occurs within the area despite there being an Article 4 direction in place, which requires planning permission to alter windows within the conservation area.
